# EAST GALLATIN RIVER AND UPPER TRIBUTARIES FLOOD HAZARD ANALYSES

## GALLATIN COUNTY, MONTANA

Report of  
EAST GALLATIN RIVER  
AND UPPER TRIBUTARIES  
FLOOD HAZARD ANALYSES  
GALLATIN COUNTY, MONTANA

July 1972

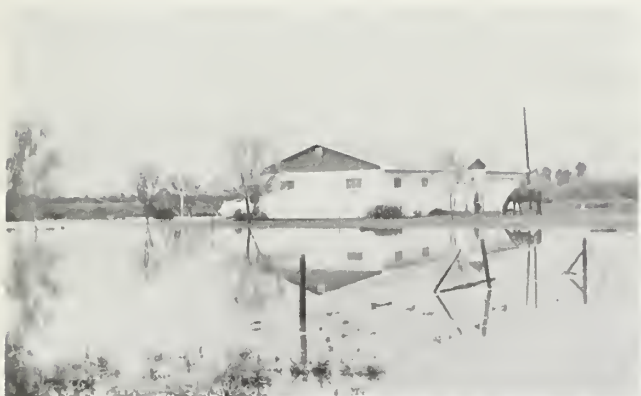
JUNE 1970 15-YEAR FREQUENCY SCS PHOTO MT-P556-4

*Flooding along East Gallatin River. These flood problems were probably not anticipated. Flood hazard studies are intended to help people identify problem areas.*

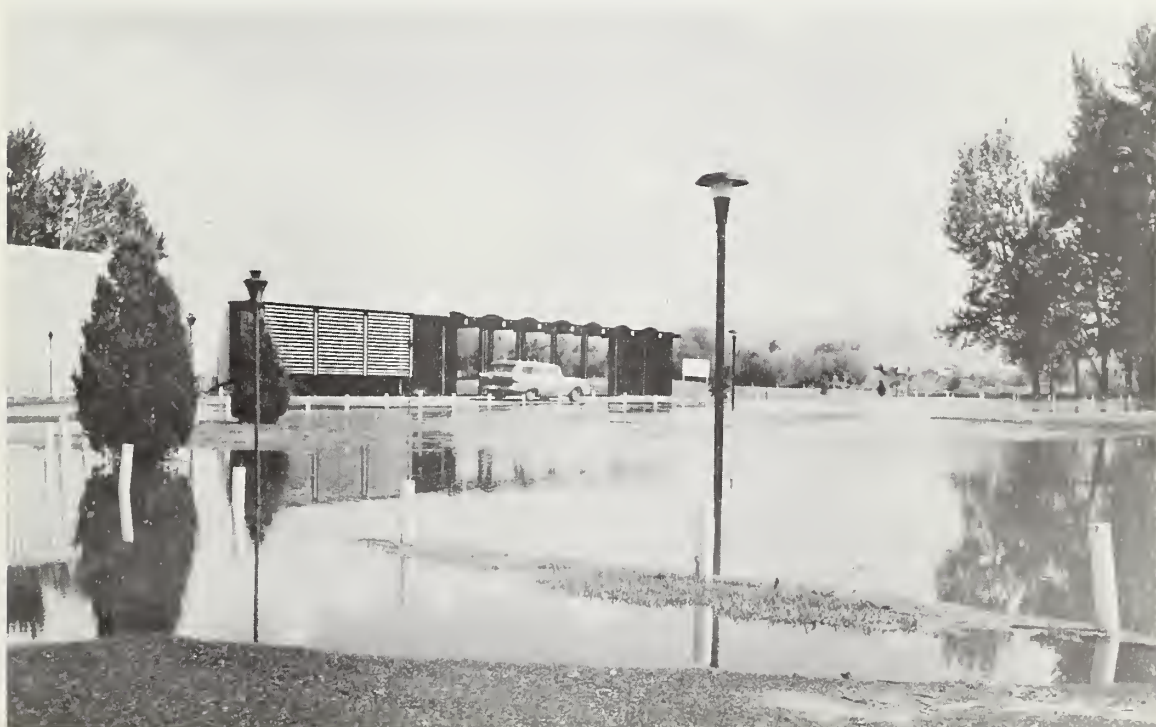
JUNE 1968 5-YEAR FREQUENCY SCS PHOTO MT-P407-6

*Floodwater in 1968 at Riverside Country Club.*

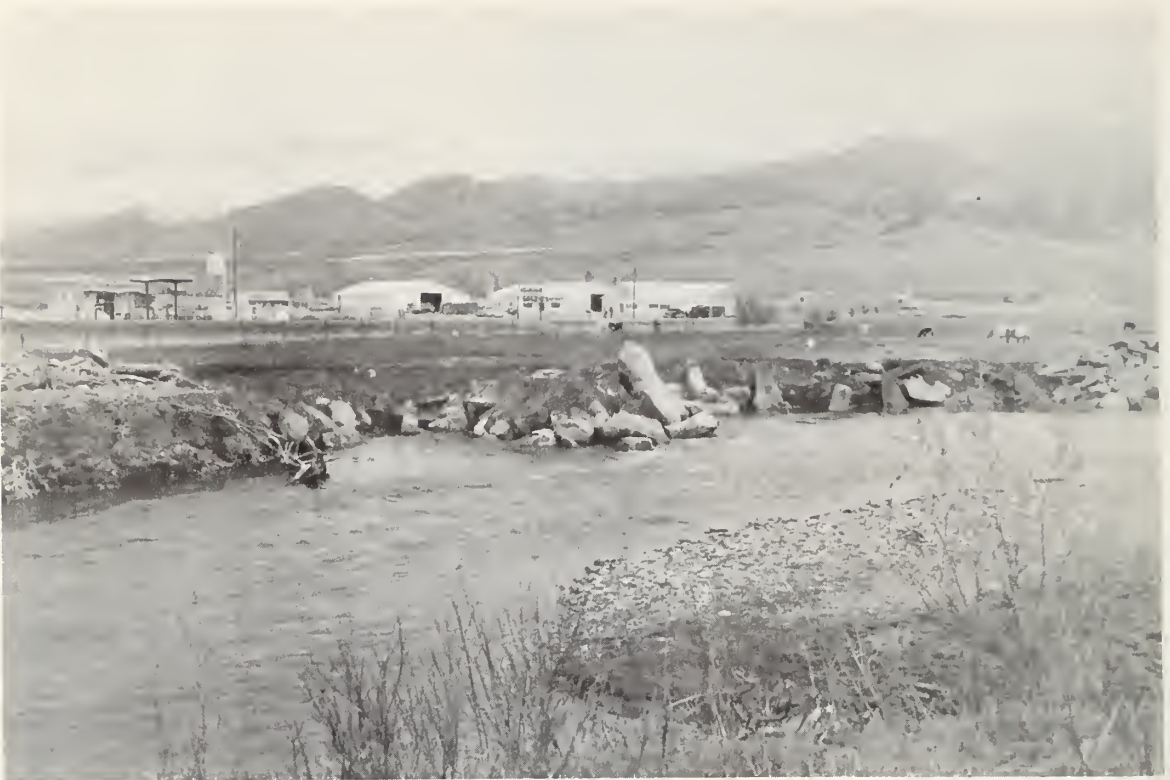
MAY 1972 SCS PHOTO MT-P969-6

*Areas with a history of flooding, such as the one shown above along the East Gallatin River, are being developed. See same area below under flooded conditions.*

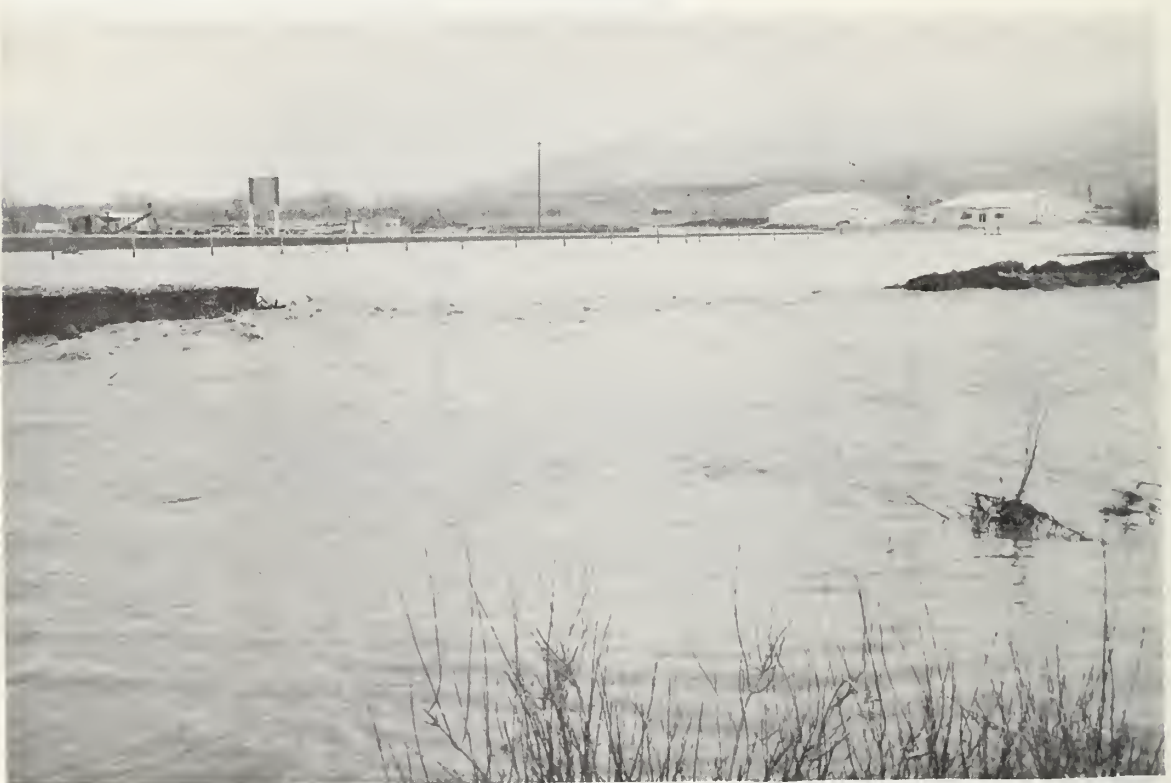
APRIL 1971 35-YEAR FREQUENCY SCS PHOTO

*Area flooded by a record event. Lesser floods also inundate portions of this area.*

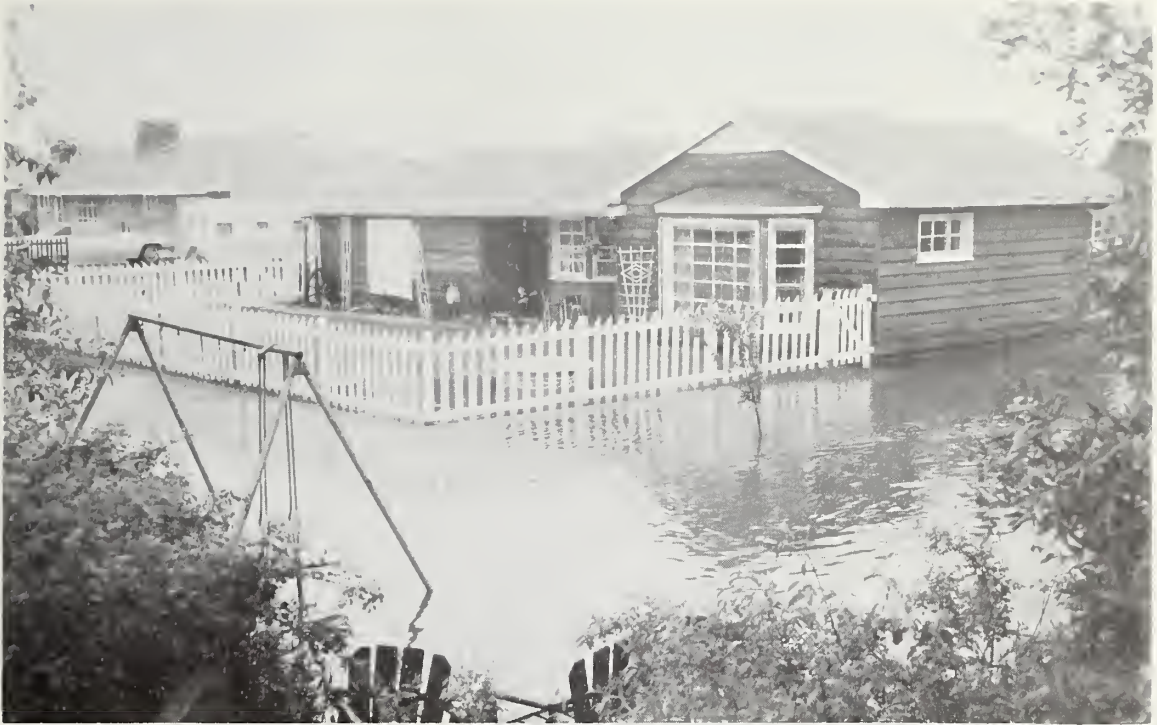
JUNE 1969 SCS PHOTO MT-P538-14

*Flooding occurs along Bozeman Creek within the city limits of Bozeman. A need exists for urban flood protection measures as well as preventing future development in such hazardous areas.*

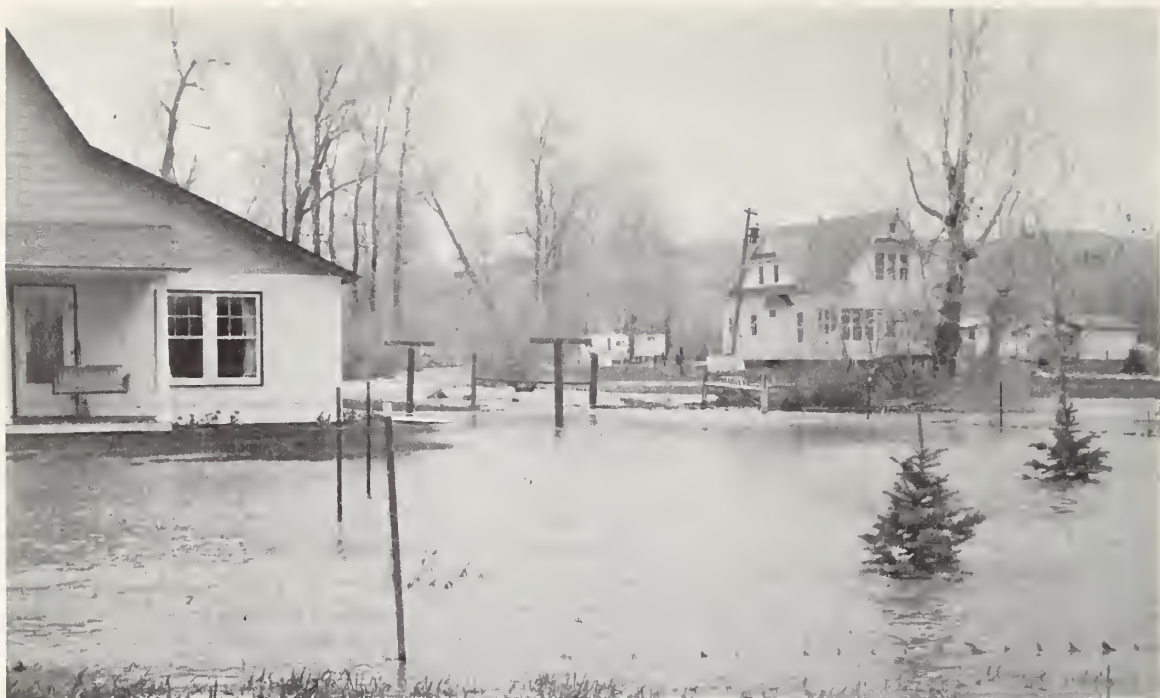
MAY 1970 5-YEAR FREQUENCY MT-P658-3

*Flooding along Bridger Creek.*

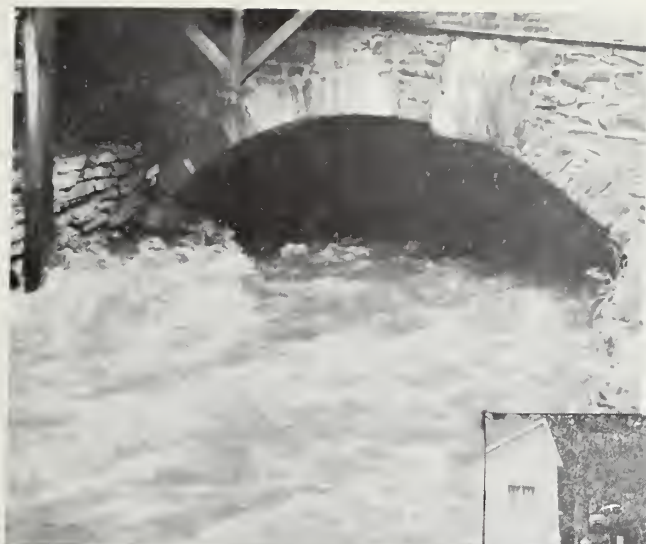
JUNE 1969 SCS PHOTO

*City bridges over the main channel of Bozeman Creek often are used at capacity. Any restriction to flows through these bridges could cause major urban damages even from relatively small runoff events.*

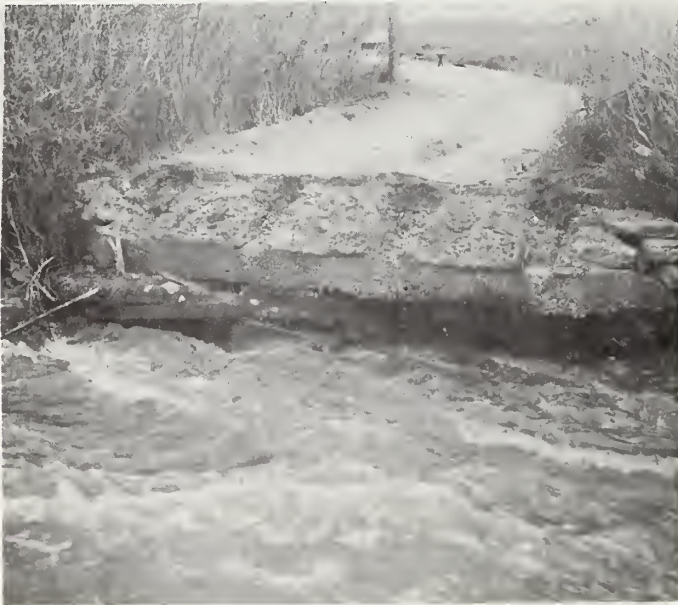
BOZEMAN CREEK MAY 1970 SCS PHOTO MT-P671-5

*Roads and bridges often have high maintenance costs when located in vulnerable floodplain areas. Maintenance costs may increase with improper channel modifications and floodway encroachment.*

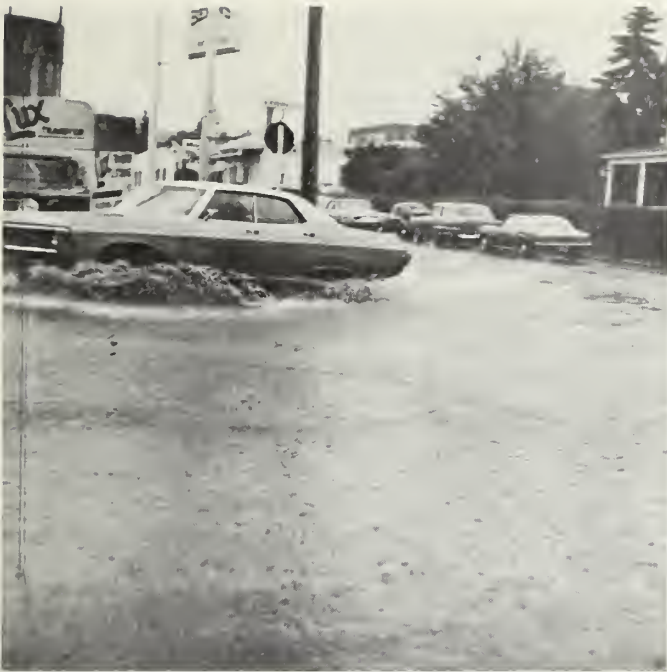
JUNE 1969 SCS PHOTO

*Flooding due to an intense local rainstorm. High water in Bozeman Creek can overflow channel banks in the south part of the city, increasing downtown flood problems.*

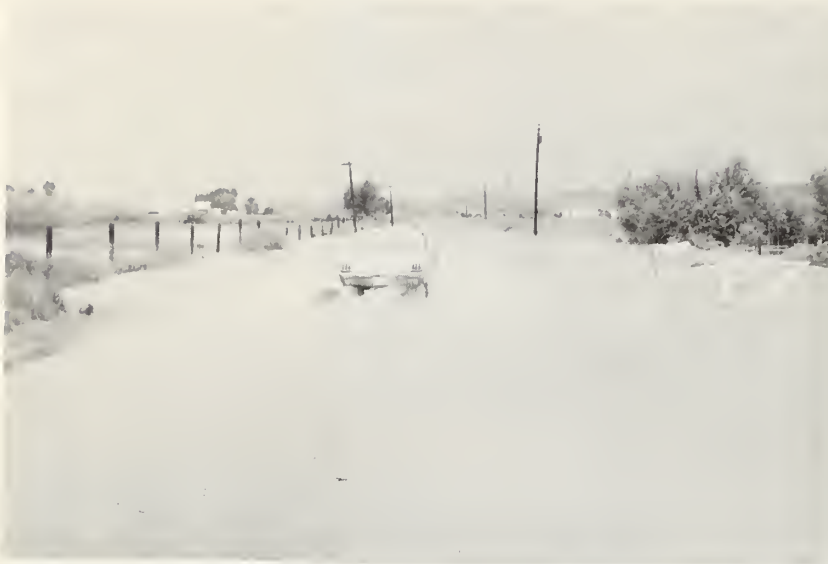
EAST GALLATIN RIVER JUNE 1970 15-YEAR FREQUENCY SCS PHOTO MT-P556-4

*People outside the floodplain area suffer inconvenience and economic damage as a result of flooding. Roads and improperly designed channel crossings can increase flood problems.*

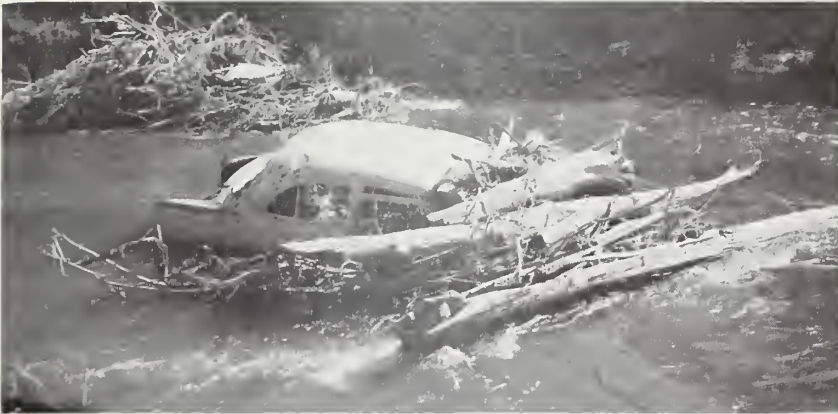
JULY 1971 SCS PHOTO MT-P876-4

*Improperly planned channel measures often contribute to erosion and flooding problems.*

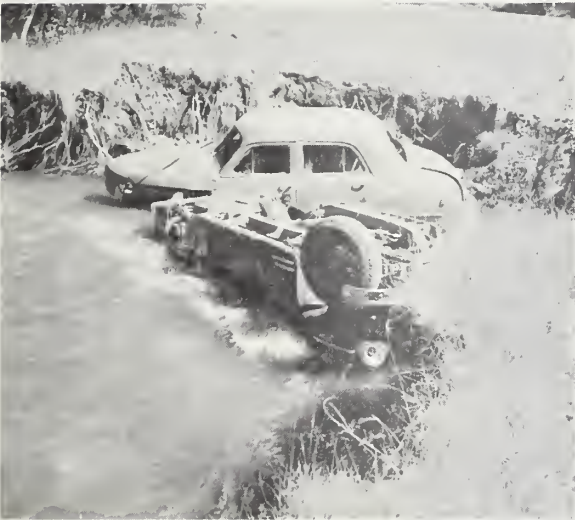
JULY 1969 SCS PHOTO MT-P581-4

*Car bodies used as riprap may create more problems than are solved. Bank erosion may be accelerated and stream channels constricted.*

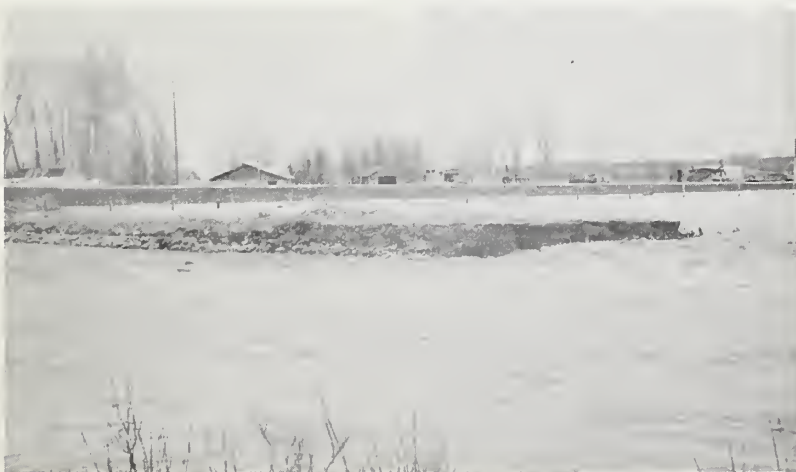
EAST GALLATIN RIVER APRIL 1971 35-YEAR FREQUENCY SCS PHOTO

*This gravel dike was not adequate.*

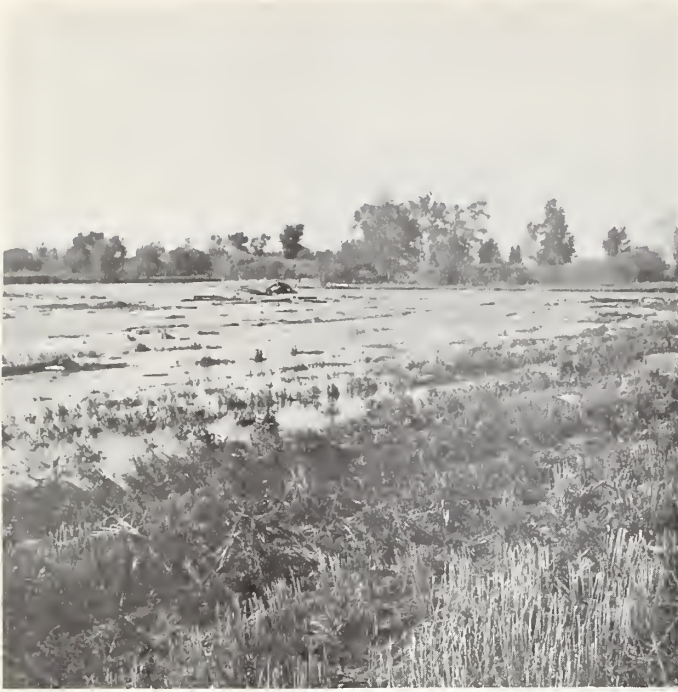
JUNE 1970 10-YEAR FREQUENCY MT-P683-3

*Floodwater on agricultural land along the East Gallatin River northeast of Belgrade.*

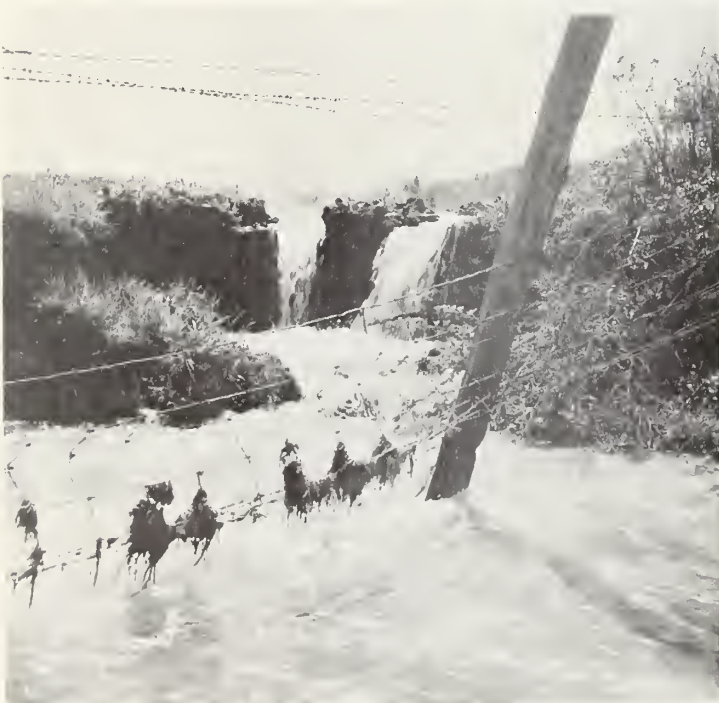
JUNE 1968 MT-P404-3

*Flood flows returning to the main channel sometimes cause washouts.*

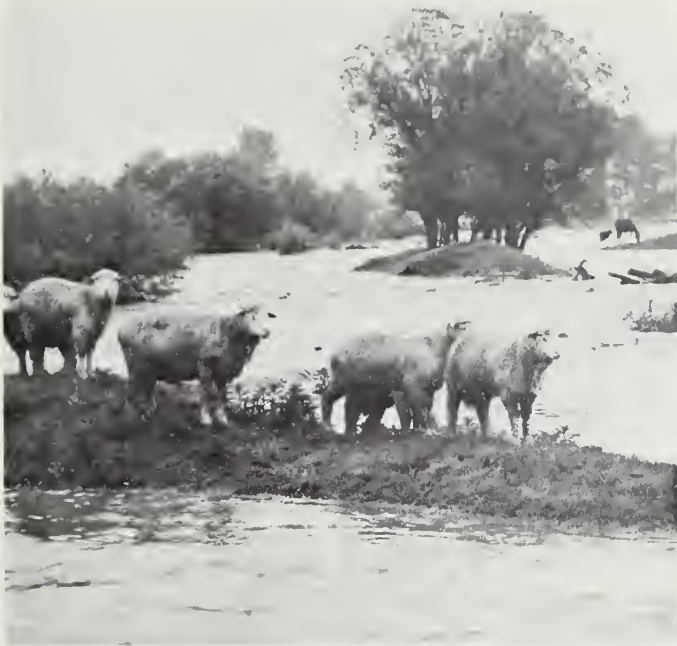
JUNE 1969 5-YEAR FREQUENCY SCS PHOTO

*Top photo shows flooding along the East Gallatin River near the confluence with Bozeman Creek. Sheep are trapped on an island.*

*Photo below shows field damage due to flows in a secondary channel.*

*Farmers as well as urban people suffer flood damages. In addition to livestock losses, soil and crop damages also occur. Proper flood plain management can reduce losses.*

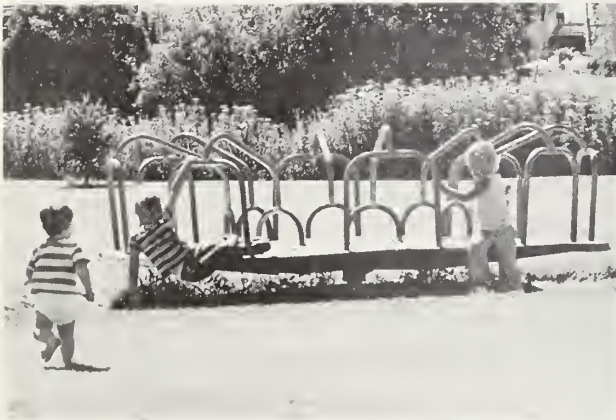
JULY 1972 SCS PHOTO

*Golf courses and parks  
are compatible uses  
for flood prone areas.*

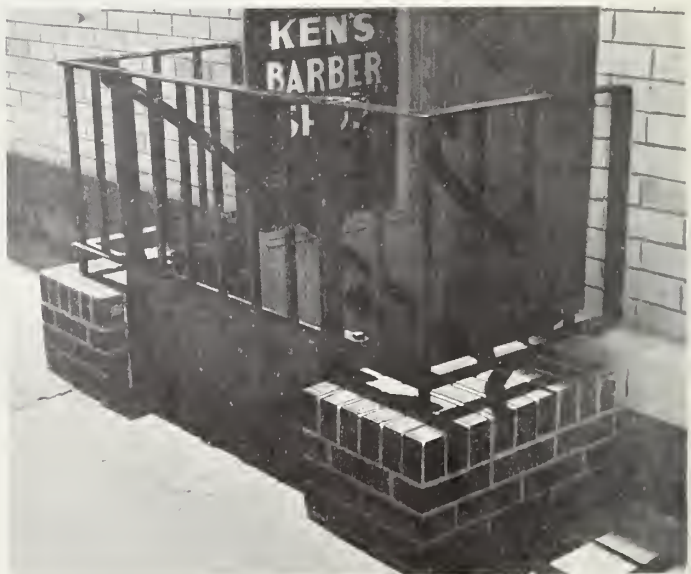
JULY 1972 SCS PHOTO

*Flood proofing  
measures such as the  
gate barrier may be  
used to protect  
floodplain property.*

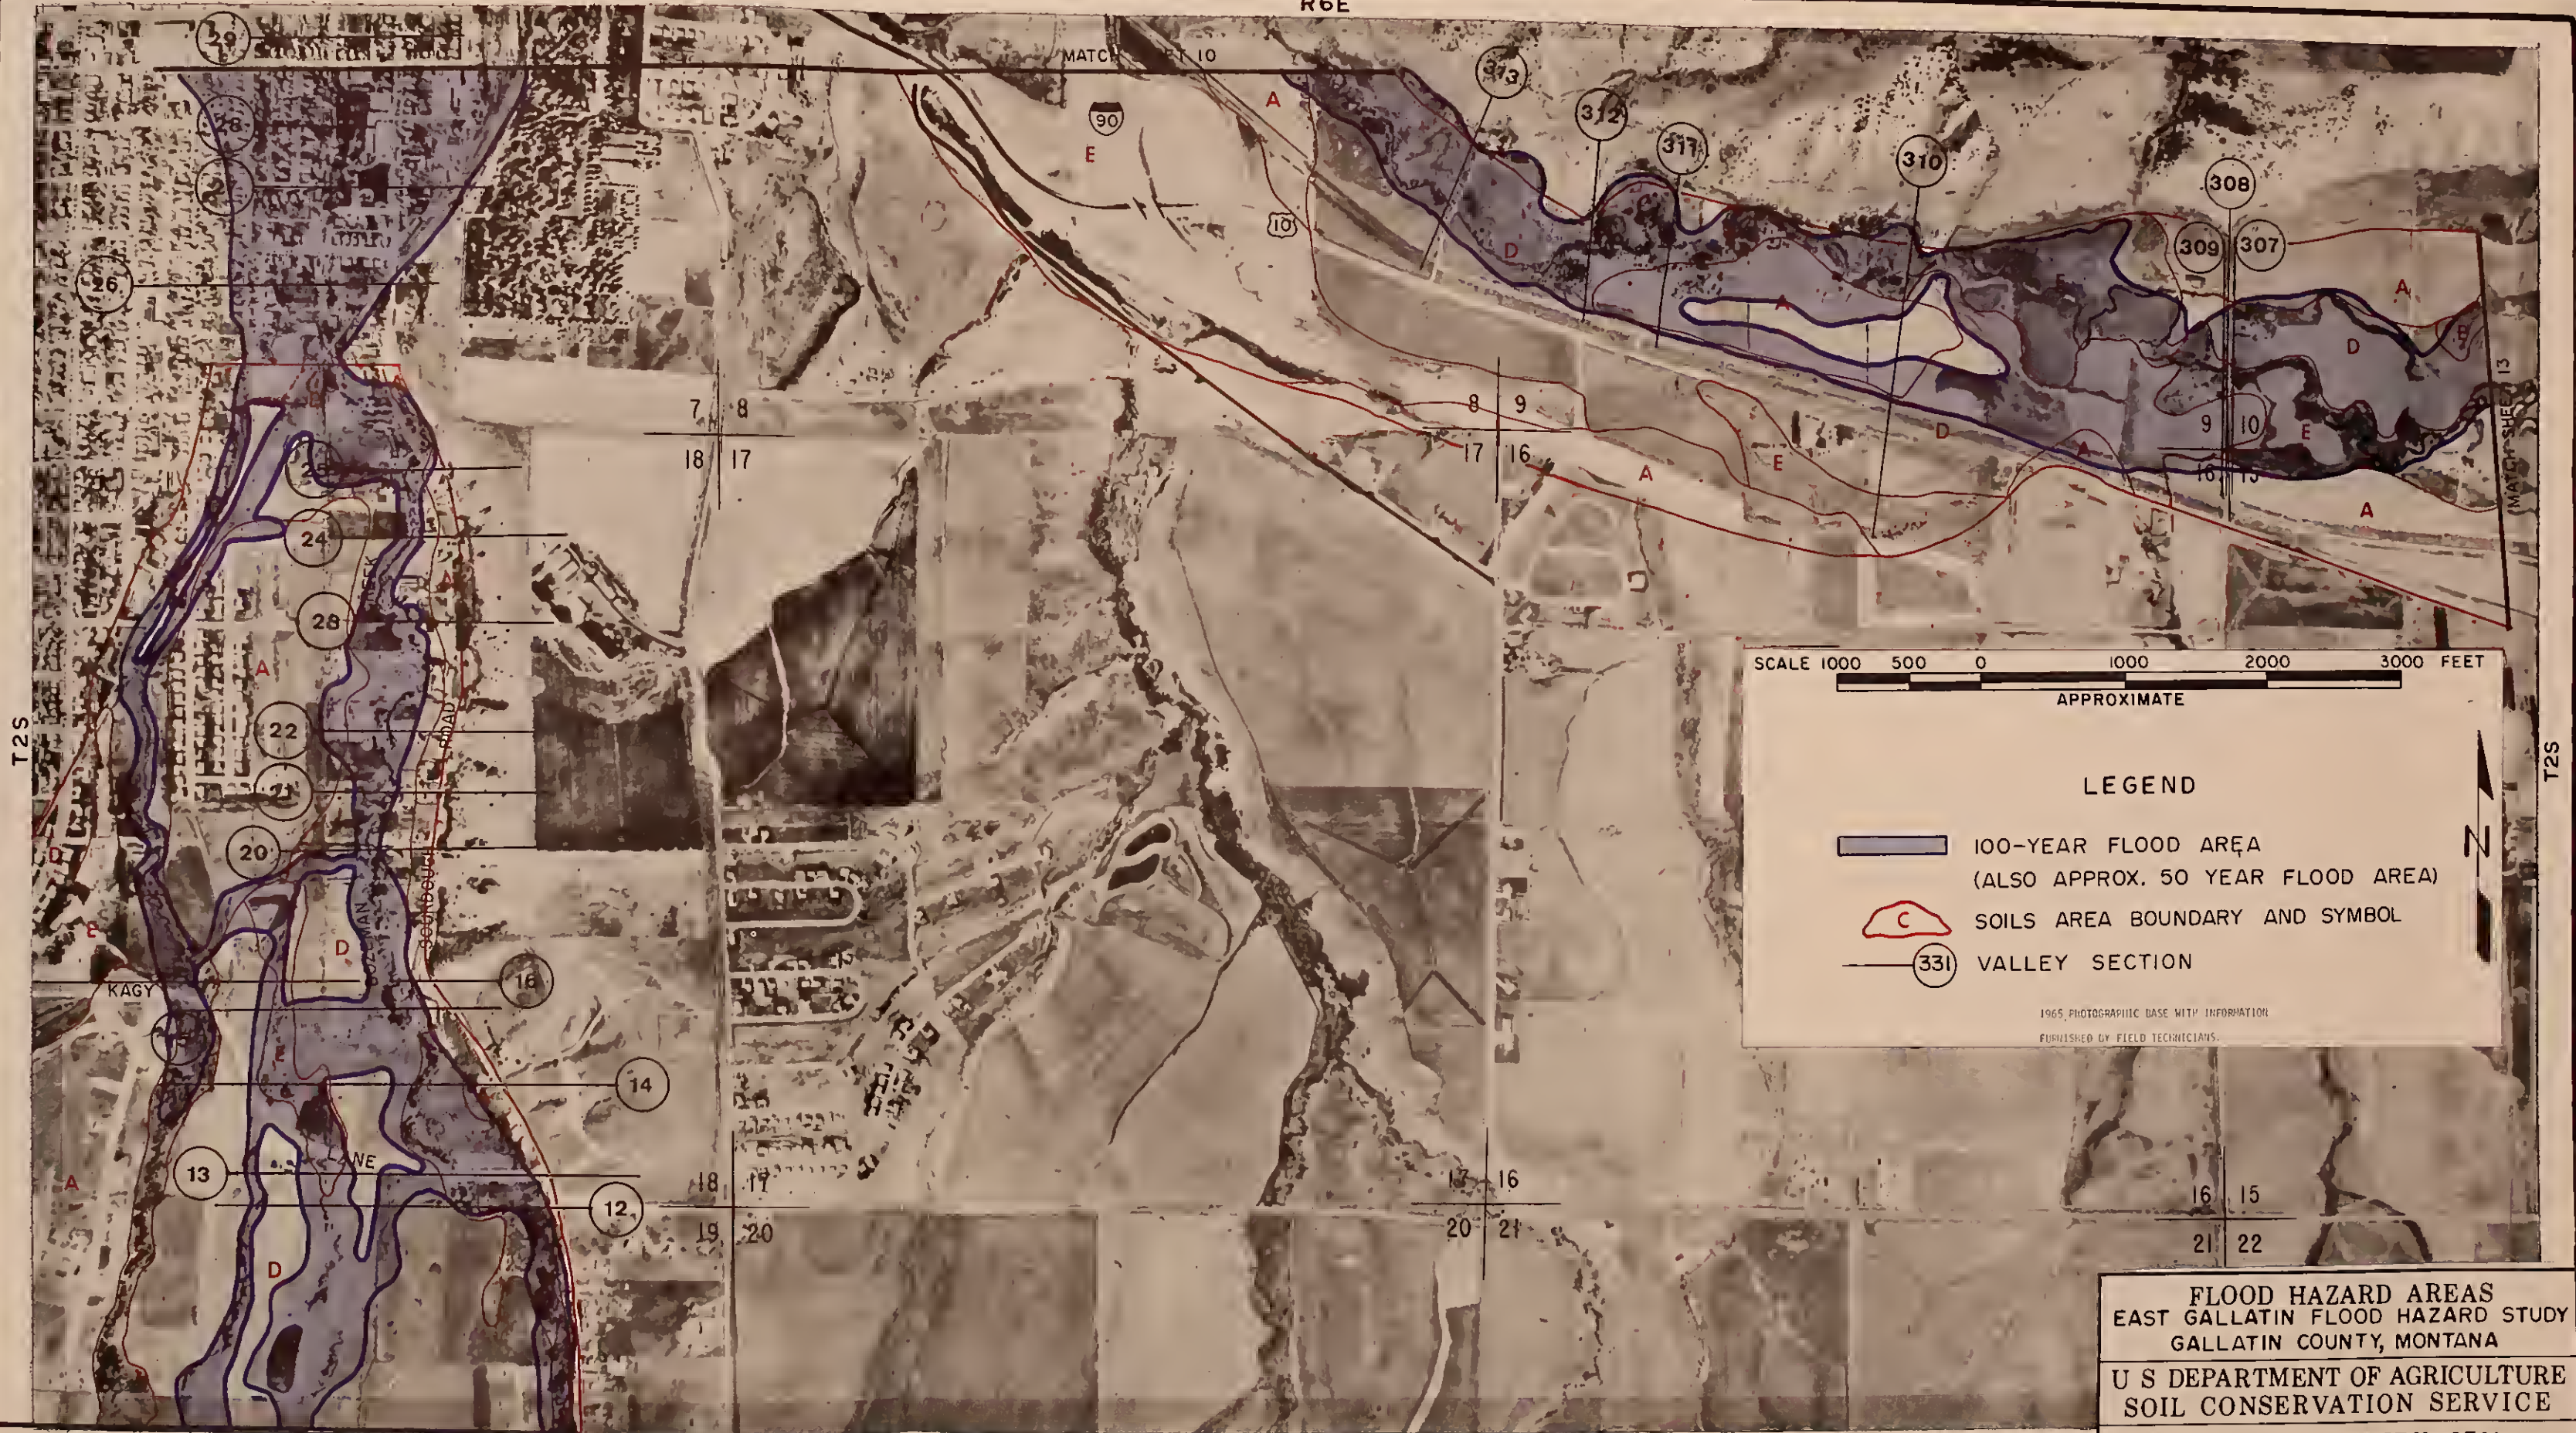
FLOOD HAZARD AREAS  
 EAST GALLATIN FLOOD HAZARD STUDY  
 GALLATIN COUNTY, MONTANA  
 U S DEPARTMENT OF AGRICULTURE  
 SOIL CONSERVATION SERVICE  
 JULY, 1972      SHEET 11 OF 16

- 100-YEAR FLOOD AREA  
(ALSO APPROX. 50 YEAR FLOOD AREA)
- SOILS AREA BOUNDARY AND SYMBOL
- 331 VALLEY SECTION

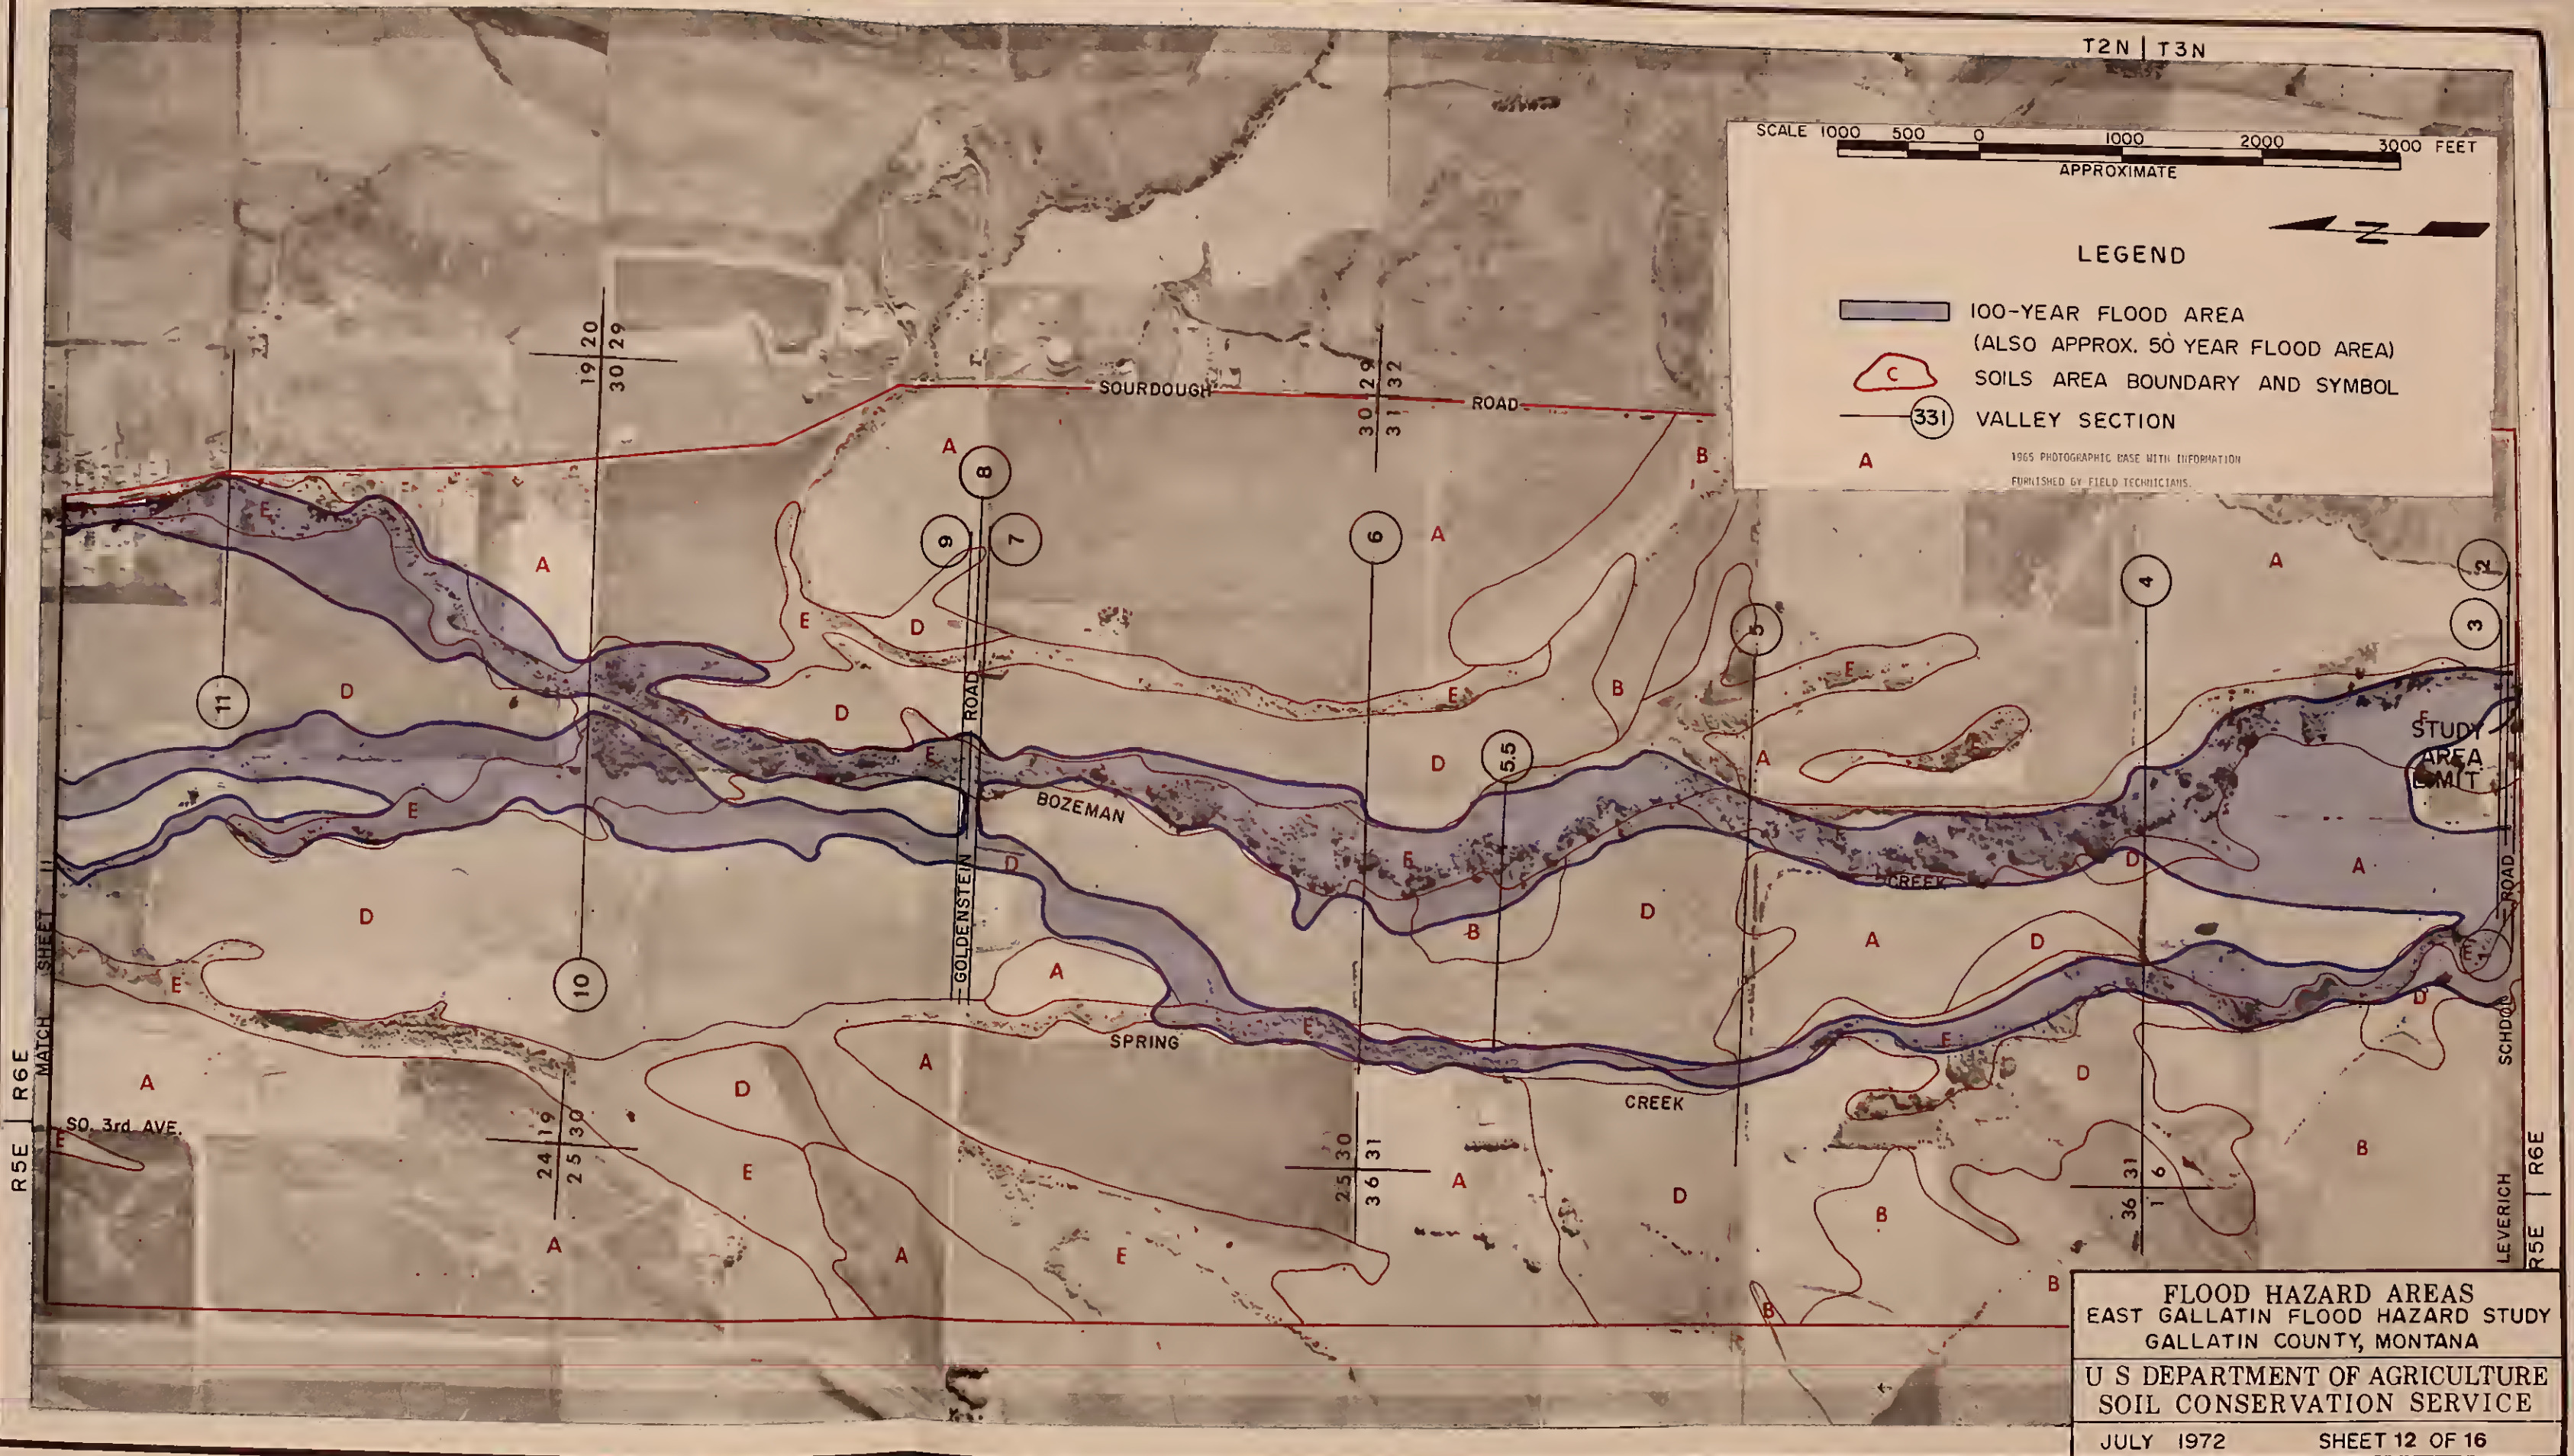
FLOOD HAZARD AREAS  
EAST GALLATIN FLOOD HAZARD STUDY  
GALLATIN COUNTY, MONTANA  
U S DEPARTMENT OF AGRICULTURE  
SOIL CONSERVATION SERVICE  
JULY 1972 SHEET 12 OF 16

1965 PHOTOGRAPHIC BASE WITH INFORMATION  
FURNISHED BY FIELD TECHNICIANS

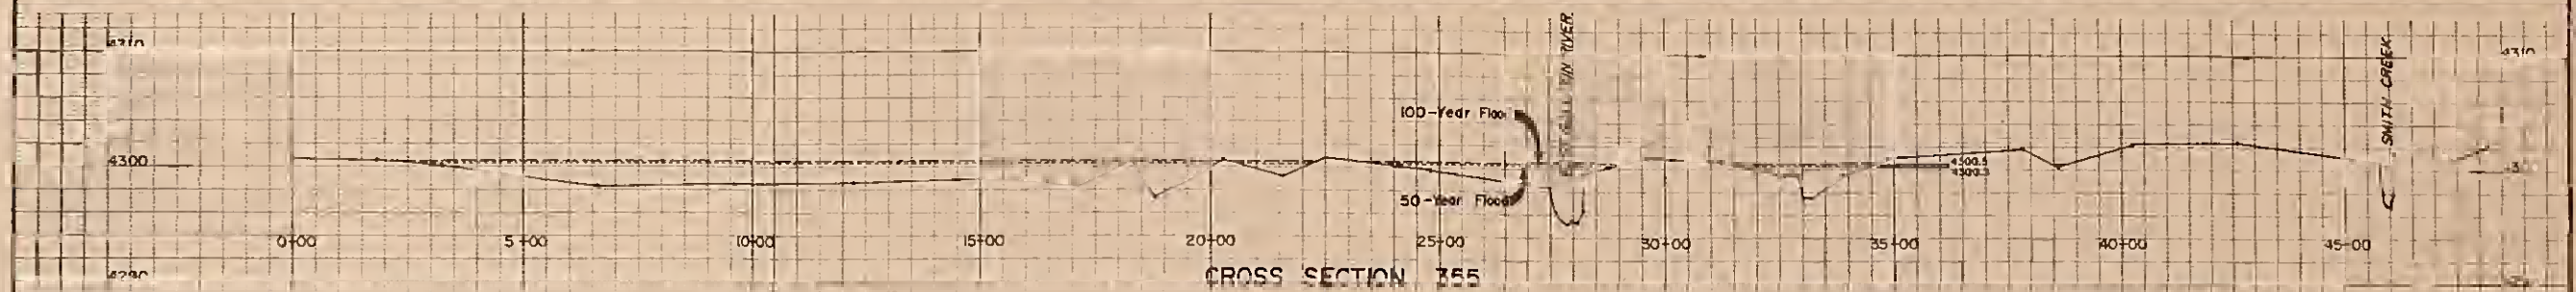
TYPICAL VALLEY CROSS SECTIONS  
EAST GALLATIN RIVER  
EAST GALLATIN FLOOD HAZARD STUDY  
GALLATIN COUNTY, MONTANA

NOTE: (1) ELEVATIONS IN FEET ABOVE  
MEAN SEA LEVEL  
(2) STATIONS IN FEET FROM LEFT  
TO RIGHT LOOKING DOWNSTREAM

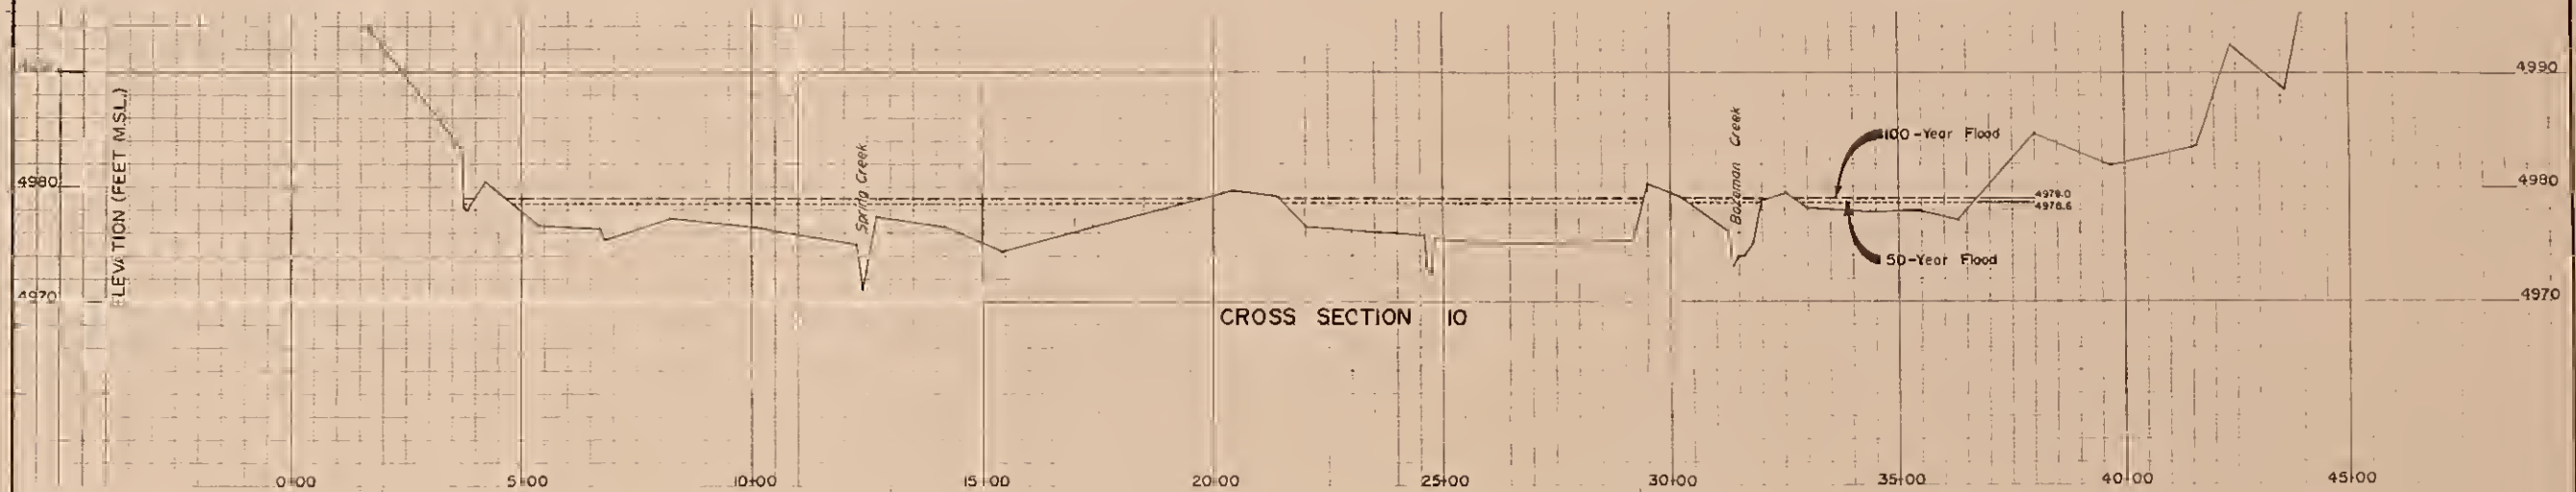
- NOTE
- (1) ELEVATIONS IN FEET ABOVE MEAN SEA LEVEL (M.S.L.)
  - (2) STATIONS IN FEET FROM LEFT TO RIGHT LOOKING DOWNSTREAM

**TYPICAL VALLEY CROSS SECTIONS**  
**BOZEMAN CREEK**  
 EAST GALLATIN FLOOD HAZARD STUDY  
 GALLATIN COUNTY, MONTANA
